PERFORMANCE REPORT

BRIDGE RESURFACINGS WITH
SILICA SAND-ASPHALT MIXTURE

Robert L. Florence
Research Engineer Associate

March, 1961

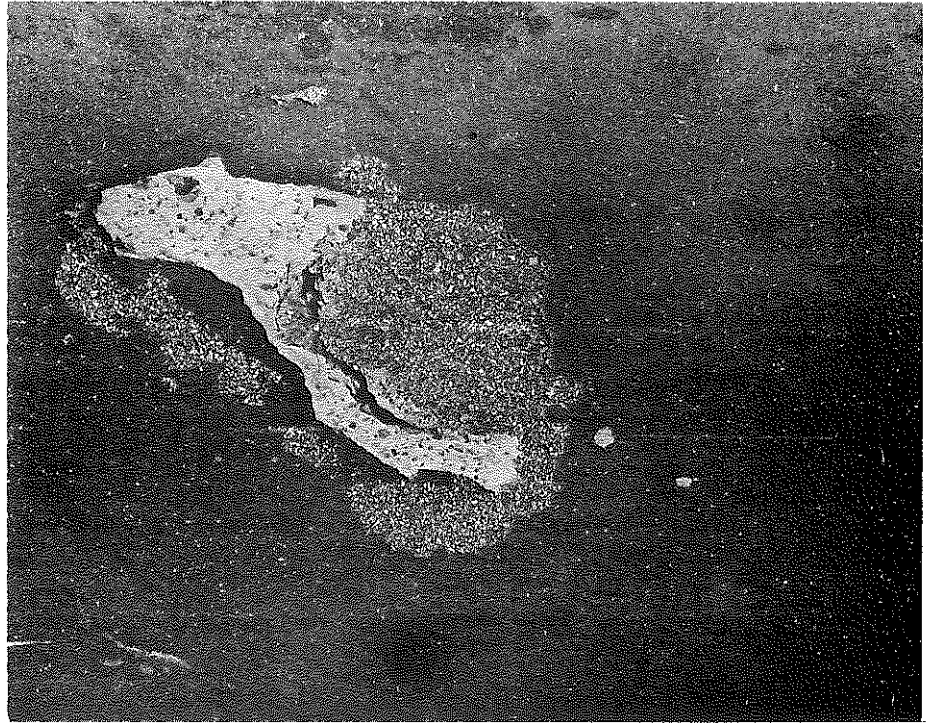
The first inspection was made March 25, 1959, five months after the sand-asphalt surface was laid. Approximately 35 small potholes, extending through the sand-asphalt and into the concrete deck, developed during the first winter. Most of the potholes had been cold-patched by Maintenance. The potholes and hairline cracking developed primarily on the approach ramps and along the gutter of the outside, north-bound lane. It was reported after this first inspection that the areas of surface showing cracking corresponded closely to those areas showing most severe damage from salt prior to resurfacing. The pothole shown in Fig. 1 was photographed at the time of the first inspection. The sand-asphalt surface was worn through in two areas on the Louisville approach ramp where the material had been hand placed and was very thin.

Fig. 1. A Deep Pothole which Developed During the First Winter.

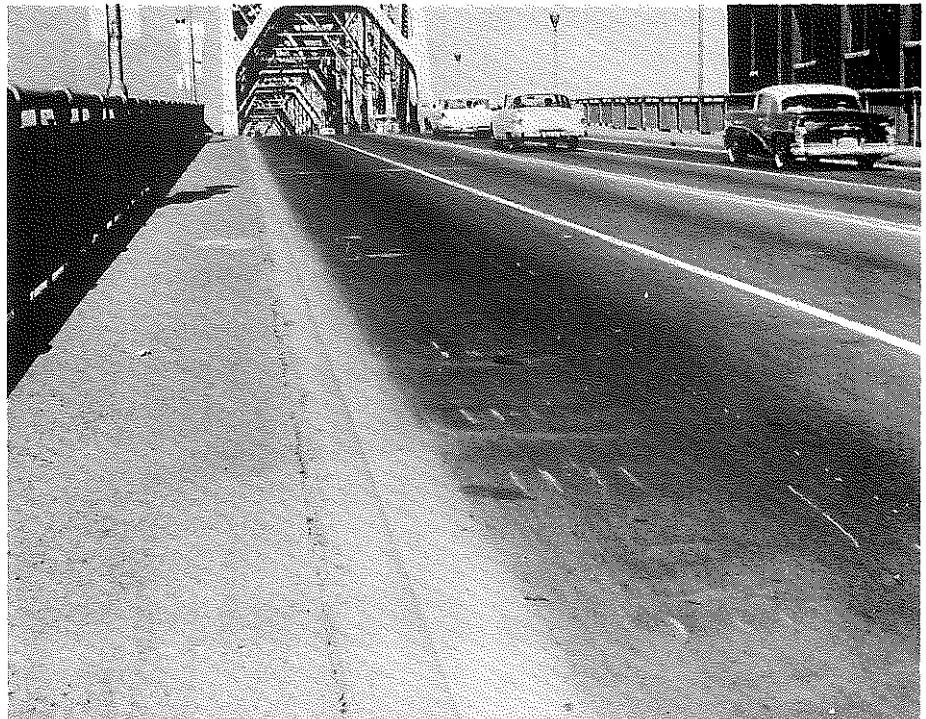
screed had worn smooth under traffic. A few small scalled areas were noted which were apparently due to inadequate tack coverage. There was evidence that the deep patches on the south-bound lanes of the Louisville approach ramp had shoved, as shown in Fig. 2. The worn areas were somewhat larger than they were at the time of the previous inspection.

Fig. 2. Shoving, in the Deeper Patches, Became Apparent Within a Year After Re-Surfacing on the Louisville Approach Ramp. South-bound traffic brakes to a stop on the grade.

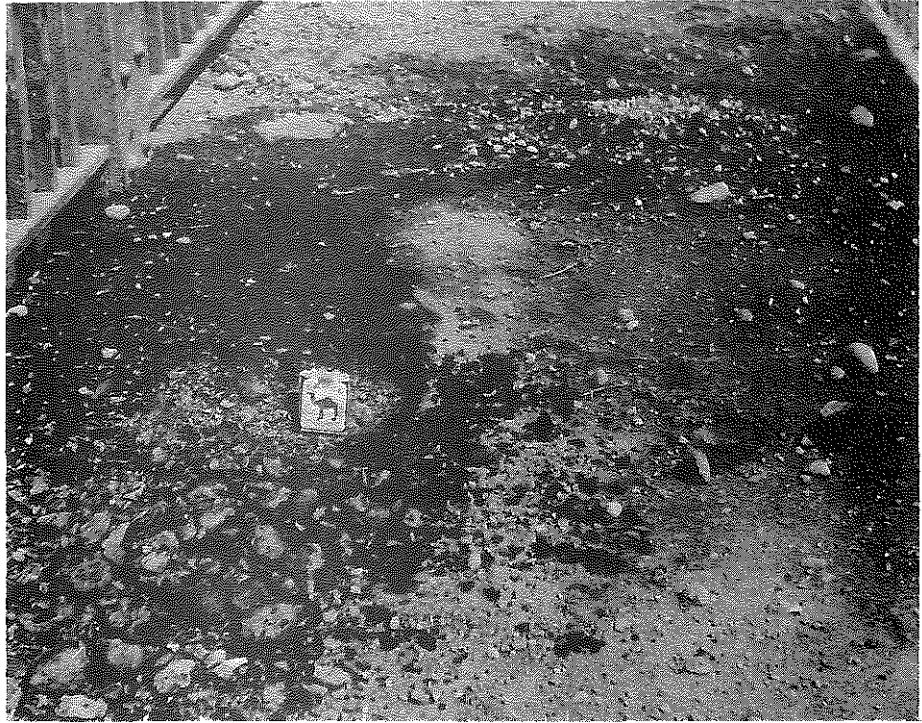
Fig. 3. Sidewalk Indiana Approach Ramp. This section of sidewalk had to be removed and bridged over with planks since this photograph was taken.

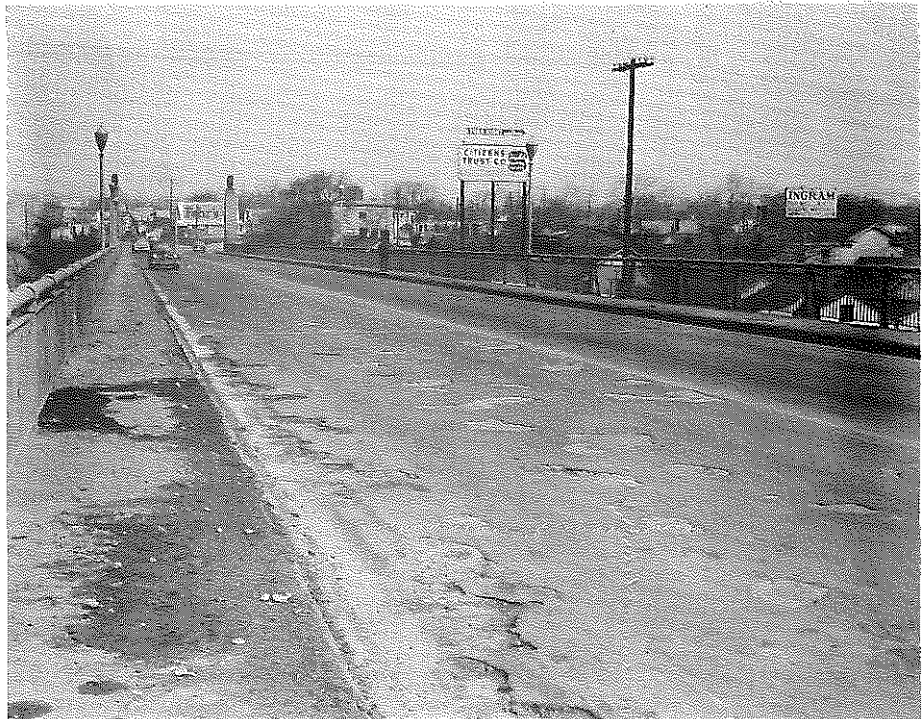
Fig. 4. The Approach Ramps Sustained the Most Severe Damage.

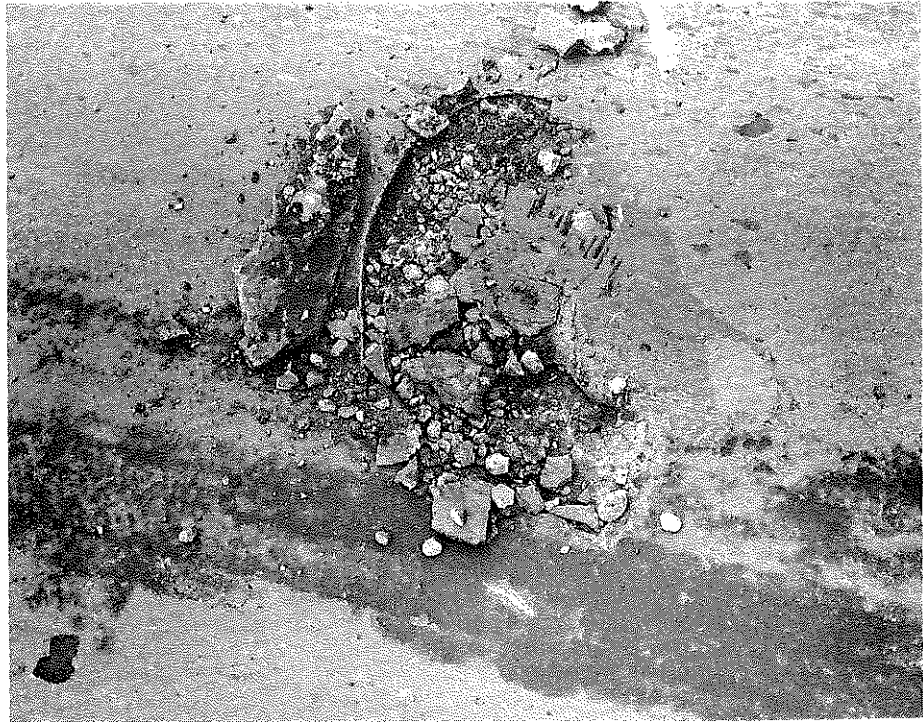
Fig. 5. Areas which Appeared as Fine Cracking Revealed Spalled Concrete Underneath When Broken Open.

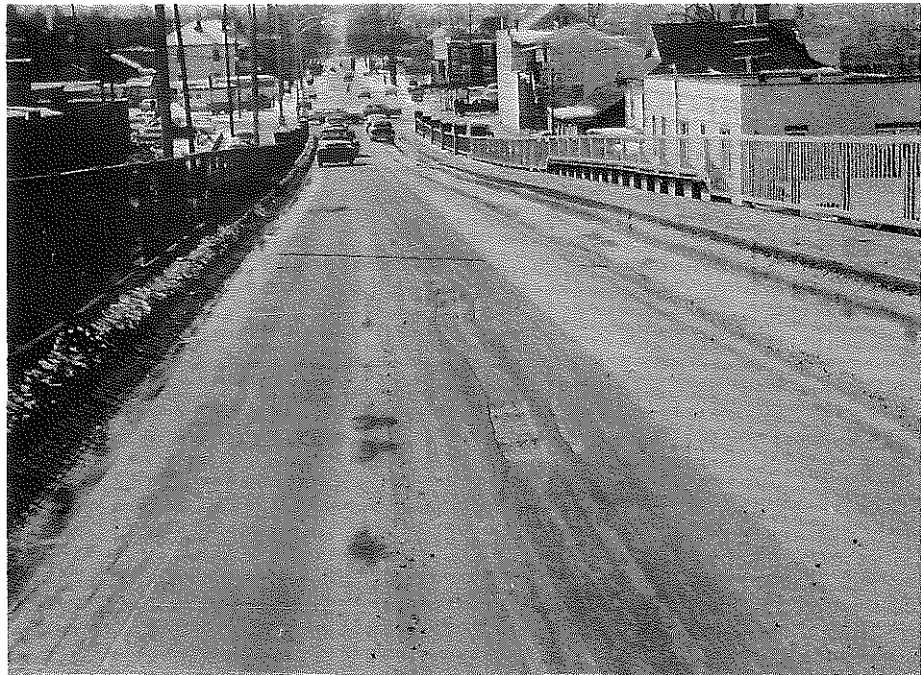
The first inspection was made February 22, 1960, one year and three months after the sand-asphalt was laid. At that time, no cracking was noted; and the only failures were ten small holes extending through the sand-asphalt and the 1-1/2 inches of asphaltic concrete to the original bridge deck. On the Ohio approach, the sand-asphalt was worn through in a turning area where the material was very thinly laid. There were tire chain scars on the Ashland approach ramp. The over-all appearance at that time was very good.

Fig. 11. Ashland-Coal Grove Bridge, Photograph Showing Tire Chain Scars on the Ashland Approach Ramp.

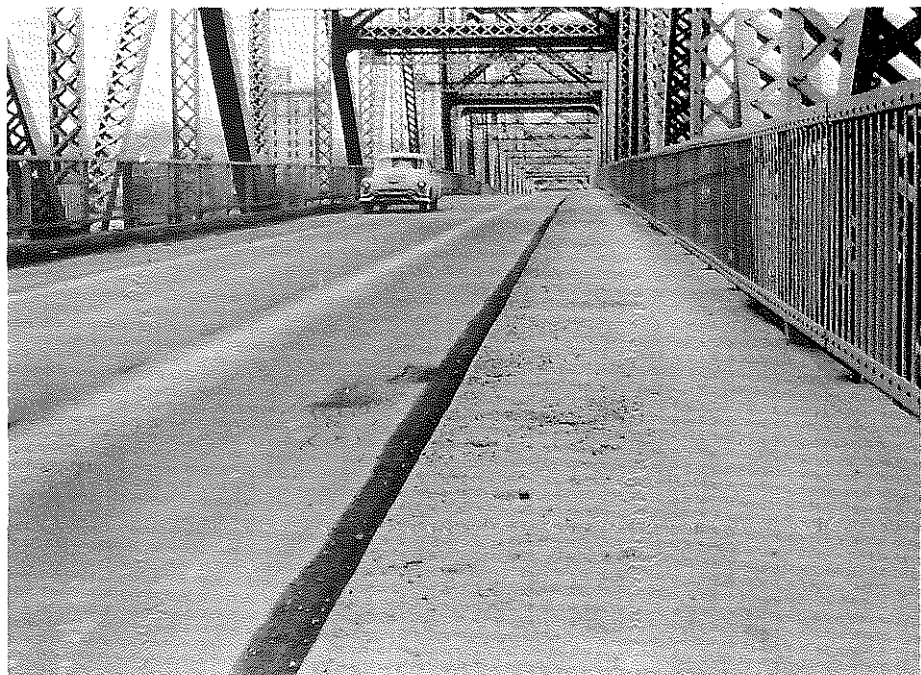
The second inspection was made March 18, 1960, just prior to the last inspection of Clark Memorial Bridge. No new holes had developed, although the sand-asphalt had peeled off of a transverse, steel joint. . There were also large areas of fine cracking -- primarily in the outside wheel tracks. In two small areas, the sand-asphalt had peeled off the underlying asphaltic concrete. Tire-chain scars were much more extensive than on the previous inspection. Of course, it is obvious from this that icy winter weather intervened between the two inspections. Some of the chain scars were through the sand-asphalt course and extended into the asphaltic concrete. No evidence of pushing, or bleeding was found on either inspection. A strip map, showing the location and types of failures noted on this inspection, is included in the Appendix.

Fig. 12. Ashland-Coal Grove Bridge, Showing Typical Appearance of Cracking in the Outside Wheel-Track, March, 1960. Cracking was not apparent before the snows of February and March, 1960.

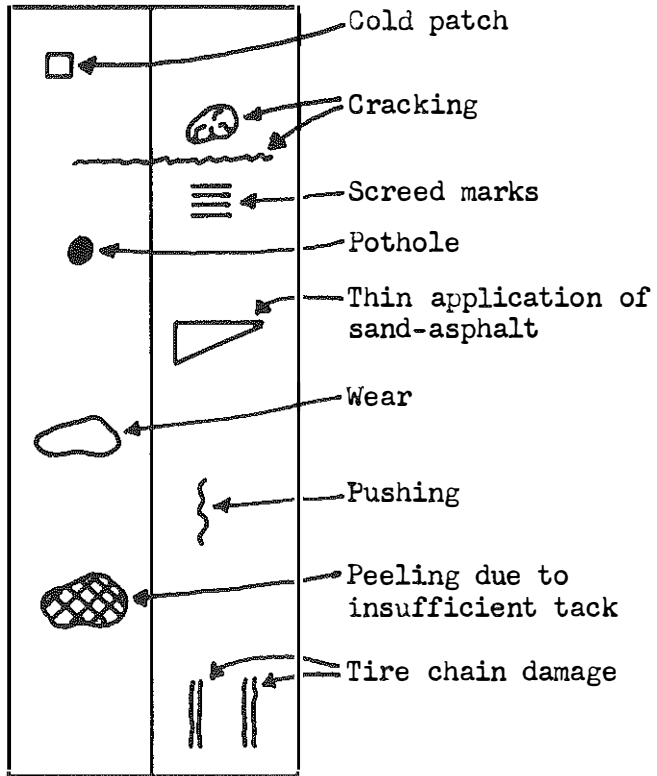
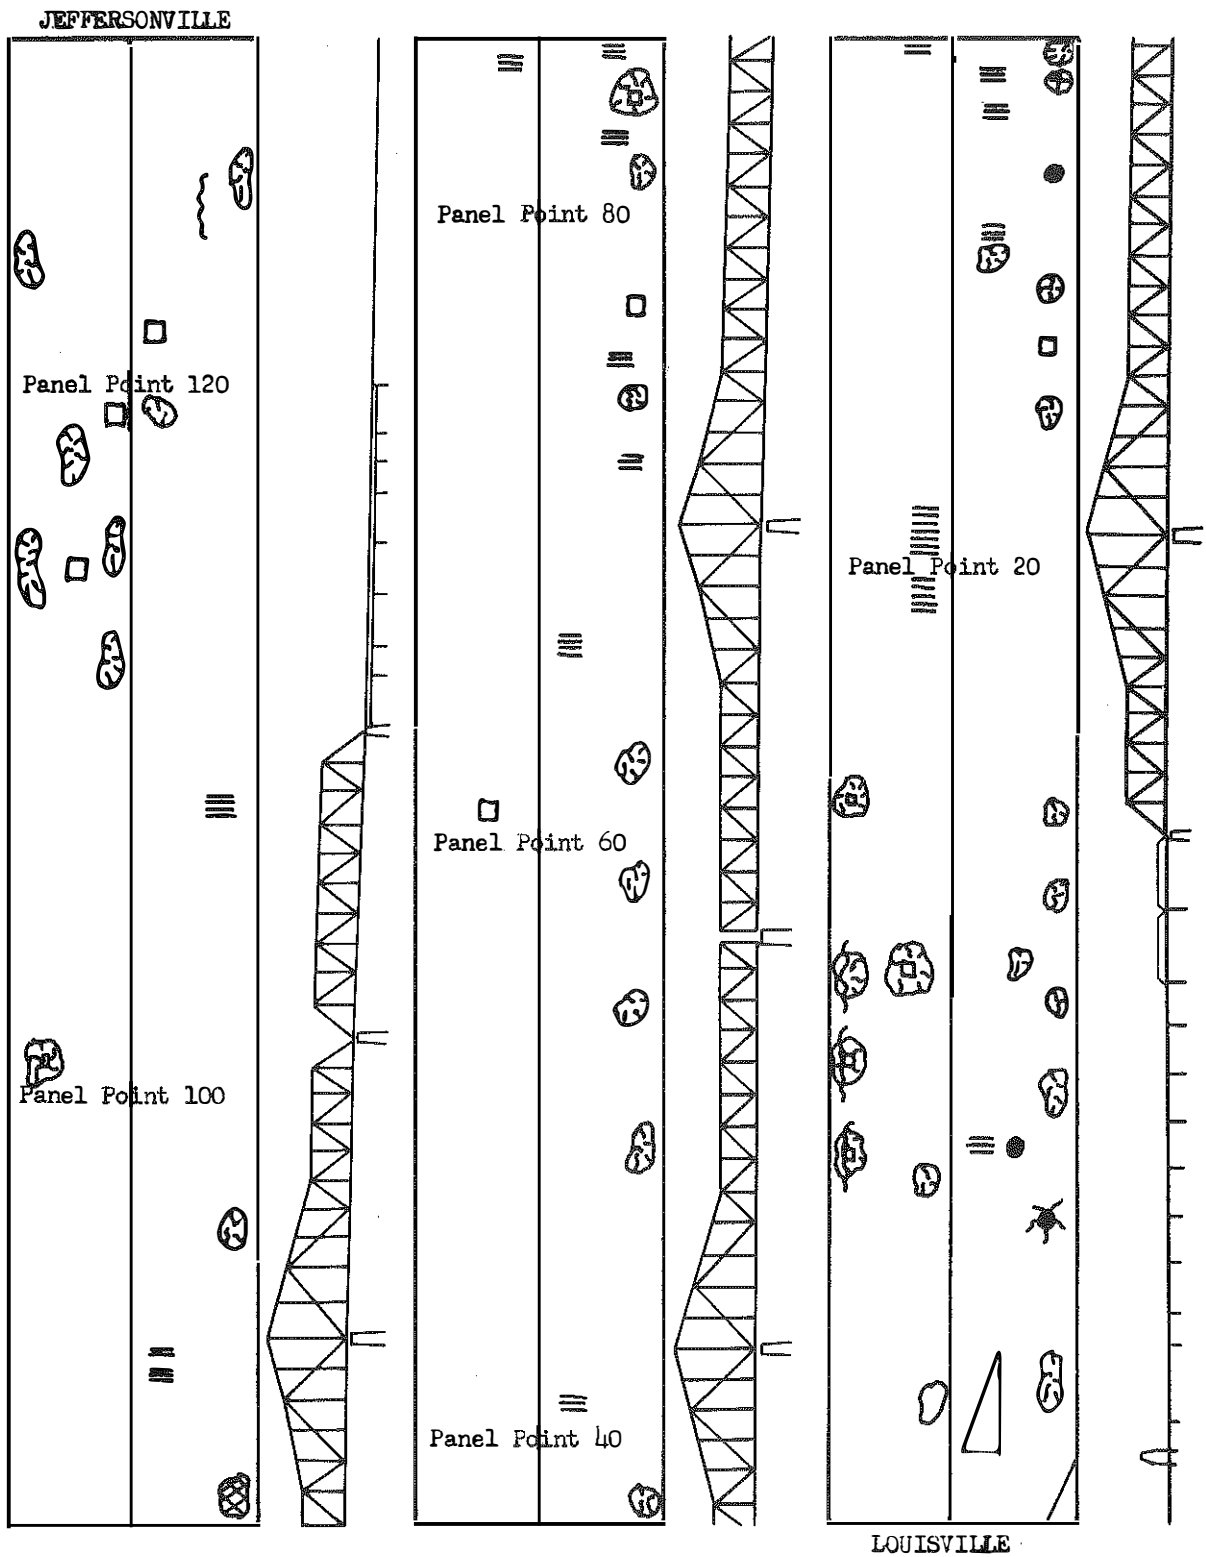
CLARK MEMORIAL BRIDGE
February 3, 1960

the cost of cleaning and patching the existing surface. The traffic count at the time of surfacing was approximately 45,000 vpd. Since the surfacing was laid, three detailed inspections have been made. A strip map showing the general location and types of failures which occurred prior to February, 1960, is included in the Appendix.
